MAZHAPOLIMA

Recharging Open Wells in the Coastal Riverine Island of VP Thuruth through 'Mazhapolima' improves water quality

Recharging Open Wells in the Coastal Riverine Island of (VP)Thuruth through 'Mazhapolima' improves water quality.

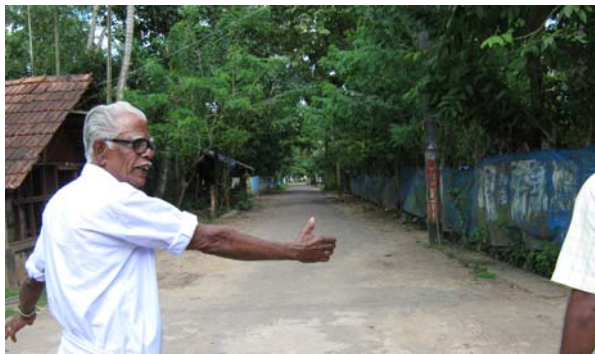
Mr. Prabhakaran Tharayil, one of the earliest occupants of the Island, explains that this road in VP thuruth was built by reclaiming and filling a canal. Activities such as these have unsettled the environmental balance and the Island ecology, mainly affecting the freshwater availability in the Island.

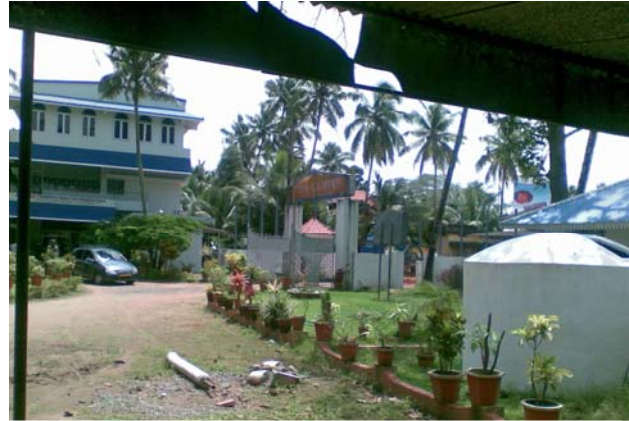
Rainwater falling on the multi-storied building at KIDS campus is collected and diverted to the well, which is given a tank like coverage structure above ground. The quality of water in this well and surrounding areas drastically improved as a result of this measure. KIDS attempted injection of rain water from a 600 square feet auditorium in to a large contaminated well in their own campus in 2005, taking advice from Mr. Terry Thomas of PLANET Kerala. This turned out as remarkable success. Water quality of this contaminated well and other wells in its vicinity improved. This is a clear example of how injecting rainwater in to one large well could influence the near by areas. The process of quality improvement of water is more effective if the soil is mostly sandy in nature. Back washing is most effective, in the sandy soil as the water could move through the interstitial space of the sandy soil, flushing out the excess nutrients and contaminants found in its midst.

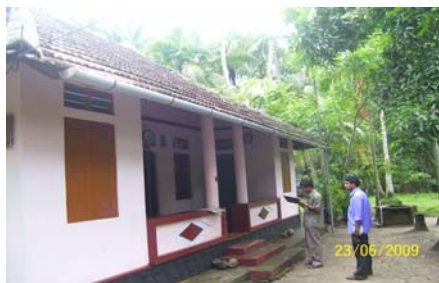
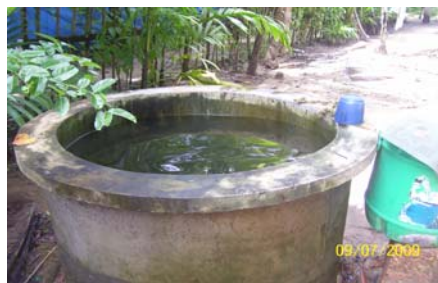
Water falling on the roof is collected through a PVC gutter and diverted through a pipe to the domestic open

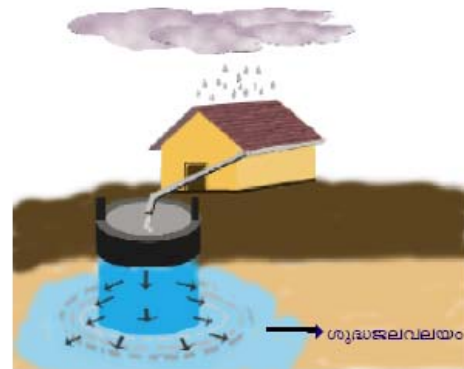
As a result of backwashing, a fresh water zone is created around the backwashed well. So the water in the well is assured to be clear and safe all the year. The physical and chemical properties of water become more acceptable.
